WATERSHED WEEK IN REVIEW

South Llano Rises 30 Feet

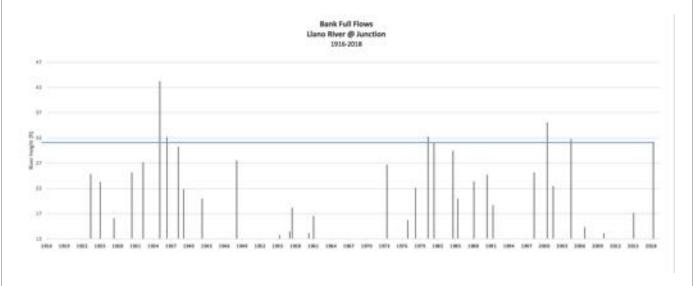
The graphic above shows the number of times the Llano near Junction has reached 12 feet, which is considered bank full. As the graphic shows, between 1980 and 2004, there were four events similar to last Monday's event.

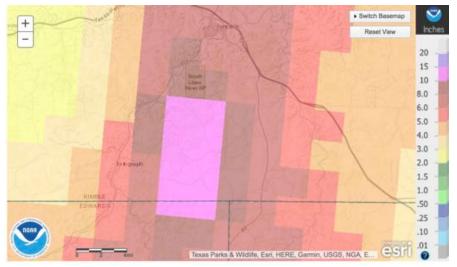
NOAA Doppler Radar image showing rainfall totals October 4 - October 11. The National Weather Service has confirmed rainfall amounts of 11.5 inches fell early Monday morning.

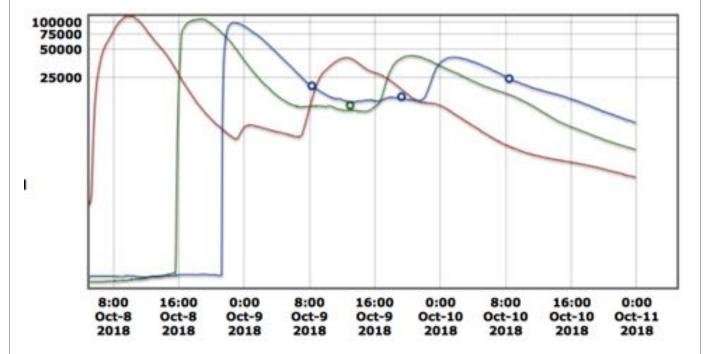
The floodwaters earlier this week raced down the Llano towards Lake LBJ. After cresting in Junction at 118,000 at 9:55am on Oct 8, a crest of 110,000 cfs arrived at the US-87 bridge near Mason at 6:30pm (elapsed time 8:35) and Llano (99,000 cfs) at 10:55pm (elapsed time from Mason 4:25). Additional rains produced a smaller second flood wave the next day which traveled the 55 miles from Junction to Mason in 7:55 (40 min faster) and the 31 miles from Mason to Llano in 5:10 (45 minutes slower). The variability in these speeds was likely dictated by flood waters from tributary streams.

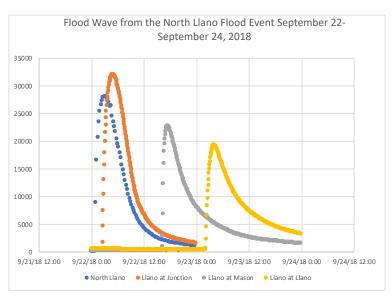
These flood waves moved more quickly than previous flood waves. Last month's flood down the North Llano took 4-5 more hours to travel from Junction to Mason and 5-6 more hours to travel from Mason to Llano (see right). Of note, last month's flood wave travel about the same speed as the flood that originated on the North Llano in 2015.

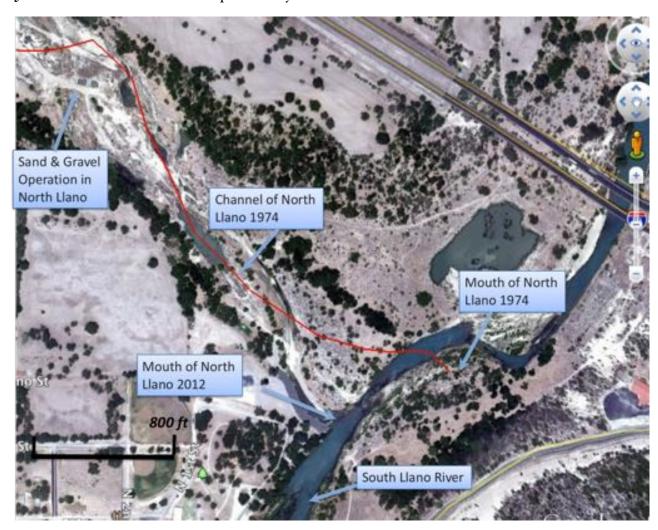
Last week, we mentioned that last month's flood down the North Llano shifted the mouth of the river (at the confluence with the South Llano) about 50 yards northward, away from the rip-rapped bank at Junction City Park. Judging from the rip rap, you might assume that the North Llano has not always been up against this bank...and you would be correct.

In fact, the North Llano used to flow about 700 feet north of where it flowed prior to last month.

What happened? In the mid-1980s, sand and gravel was extracted from the North Llano about one mile above the confluence. Texas Parks and Wildlife oversees extraction of such materials from navigable waterways through the issuance of permits. Although the permit for this operation was retired in 2004, the impacts are still visible. The mining activity within the channel caused the channel to migrate southward. The resulting erosion caused by this migration forced the City of Junction to undertake actions to protect city infrastructure.
